Report on the Condition of

FOLLY TOWER, FARINGDON, OXON

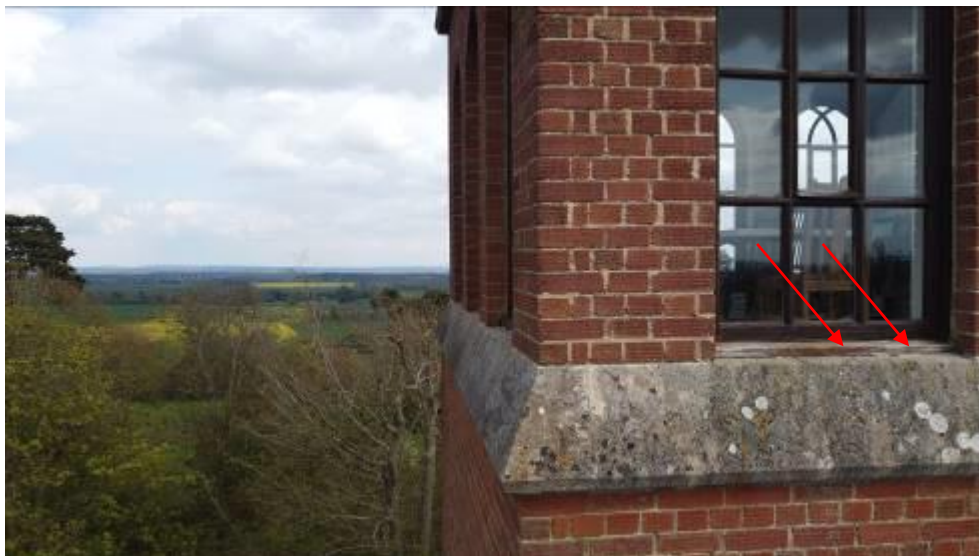
Figure 4 Cill level of windows in west wall of Belvedere showing defective pointing below timber cill and shallow fall on stone cill of string course

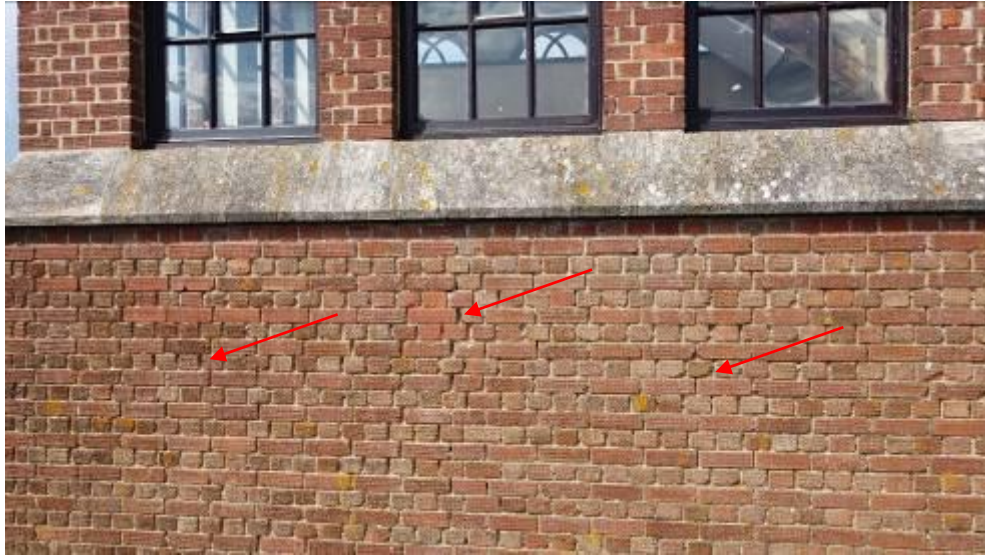
Figure 5 Cill/string course below windows in south wall of Belvedere showing deep open joints in brickwork

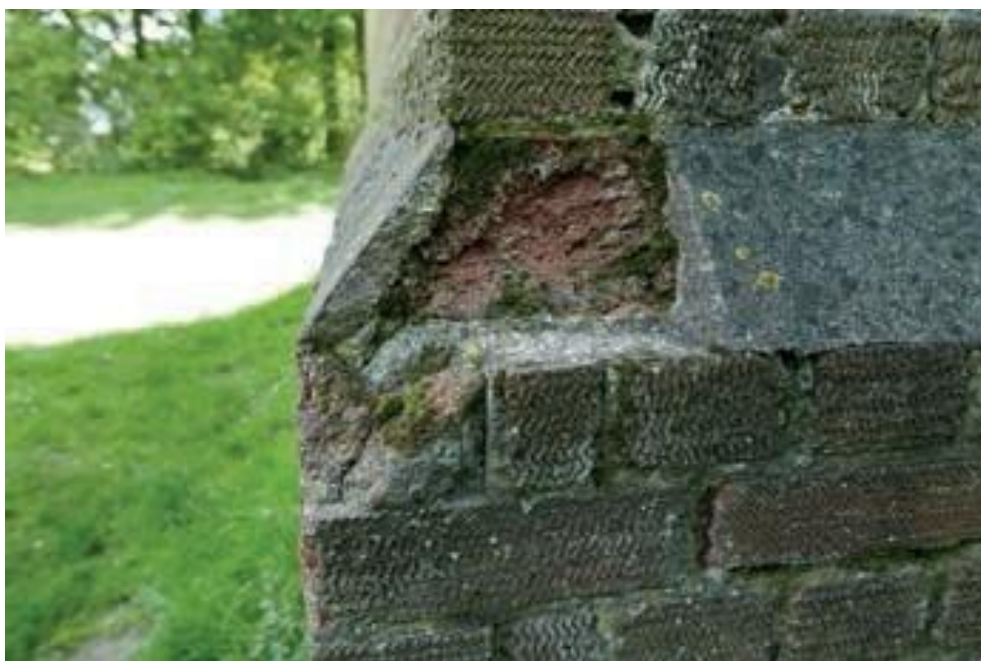
Figure 8 Detail of damage to plinth

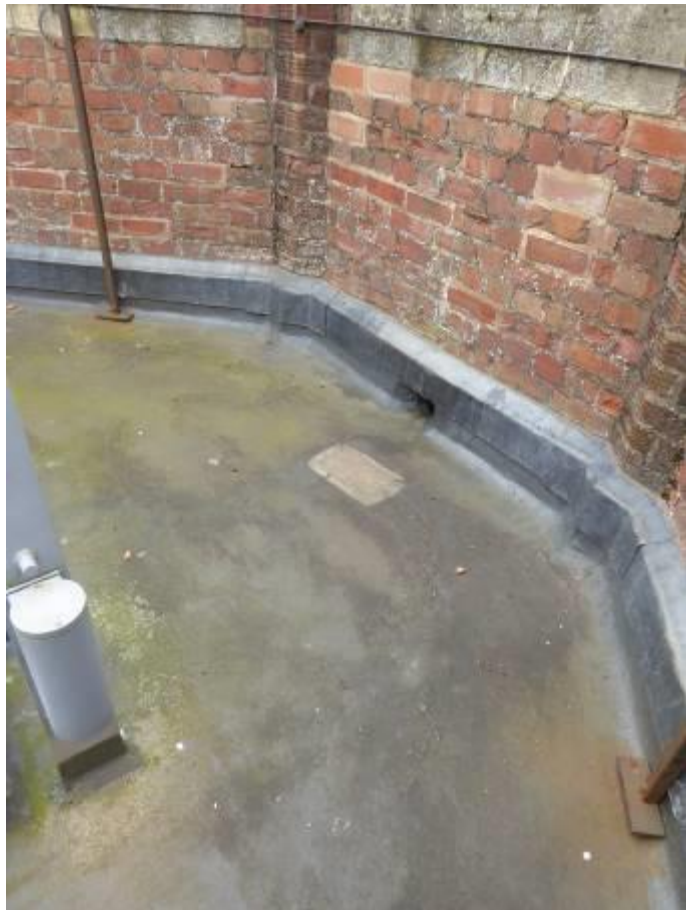
Figure 9 General view of north side of roof with asphalt covering and lead cover flashings

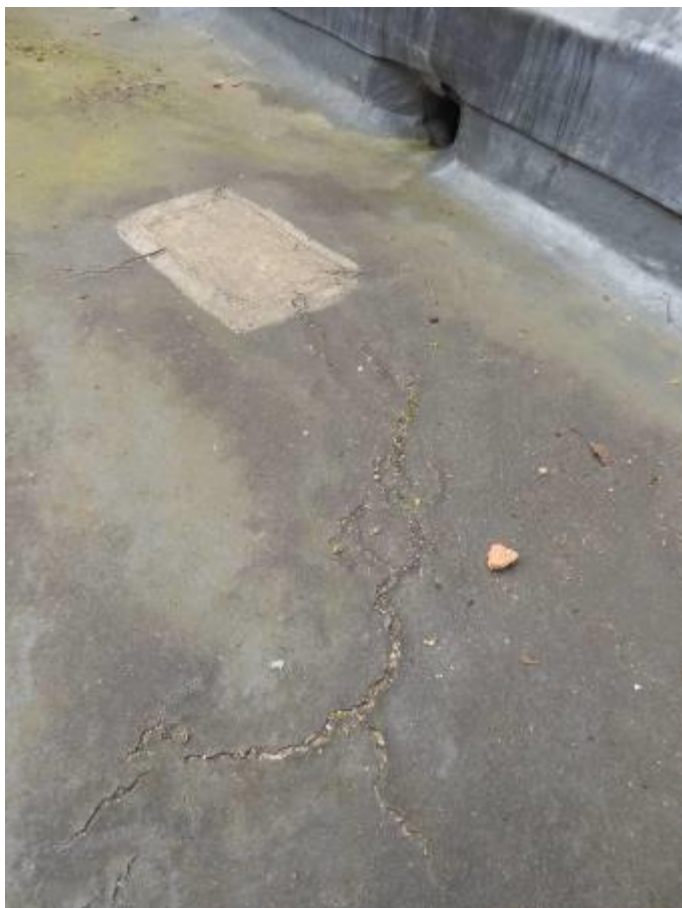
Figure 10 Detail of same showing patch repair and cracking to upper surface

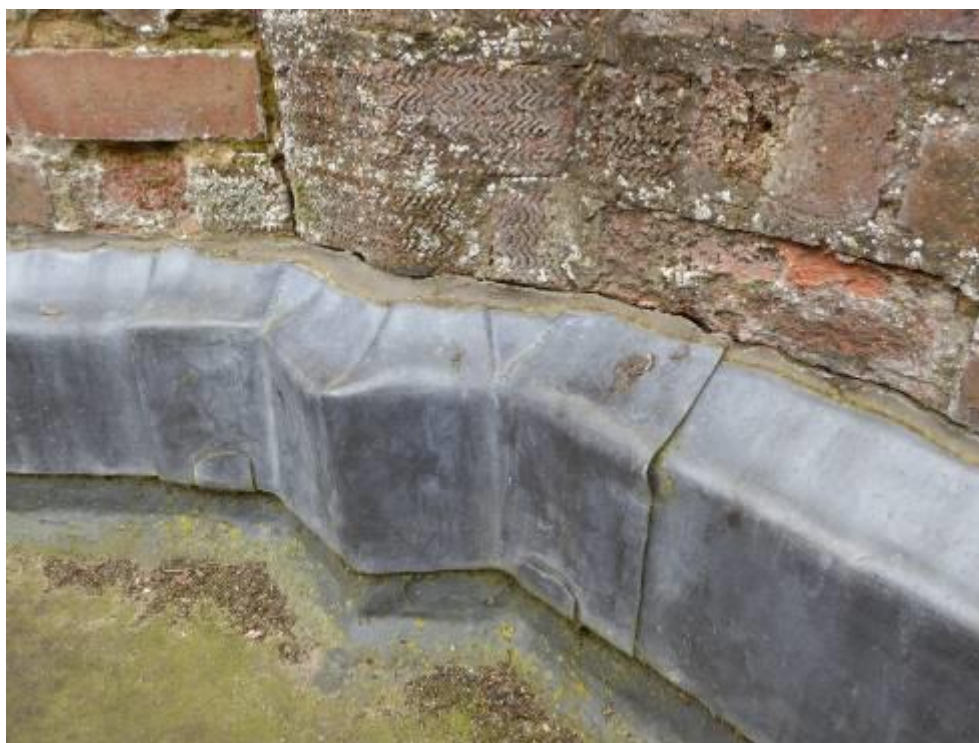
Figure 11 Open joint at head of lead cover flashing to roof

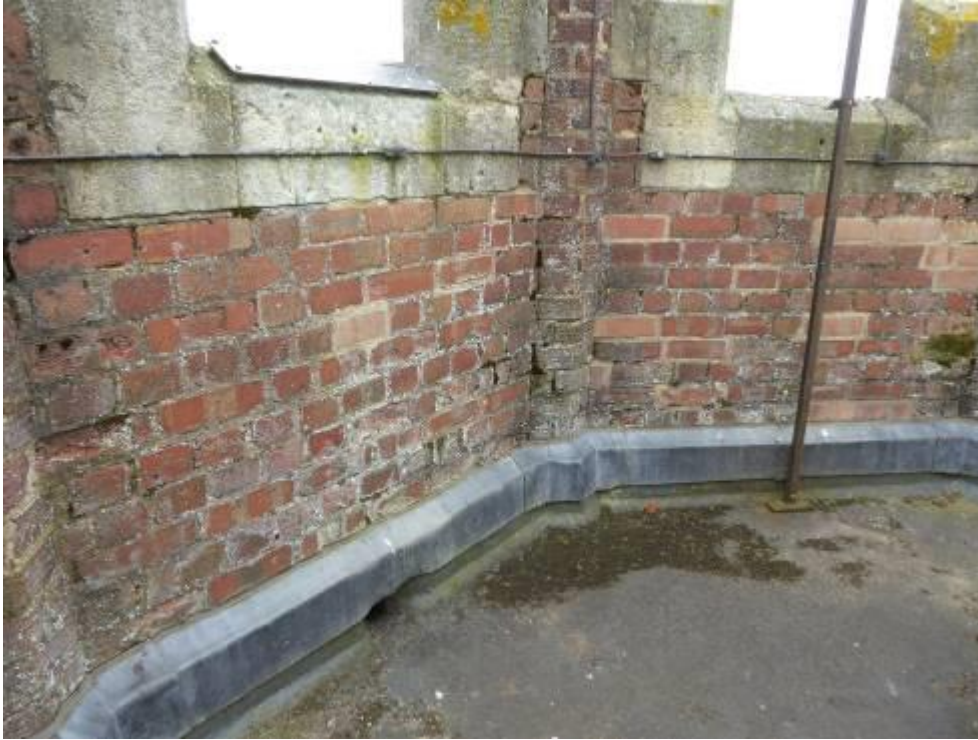
Figure 13 General view of inner face of parapet showing open joints and spalling bricks. Note also corroded steel stanchion supporting star decoration and signs of water ponding on the asphalt roof covering

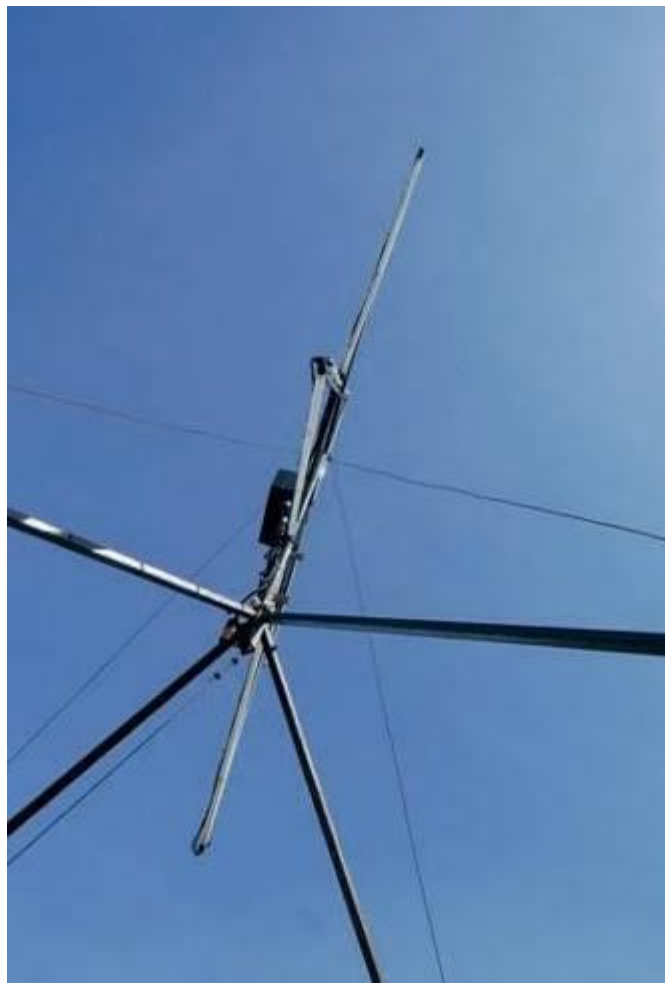
Figure 14 Star light decoration

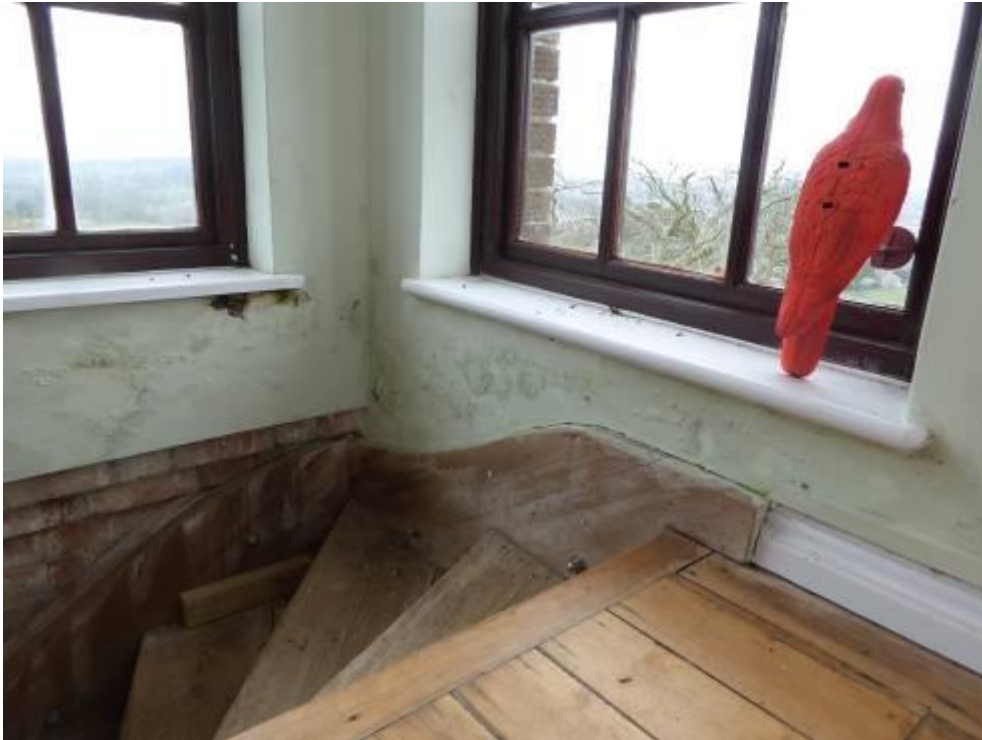
Figure 17 Damage to internal wall finishes in south-west corner of Belvedere room – this occurs generally on the weather sides and appears to be due to failure of pointing between the timber window cills and stone cills below

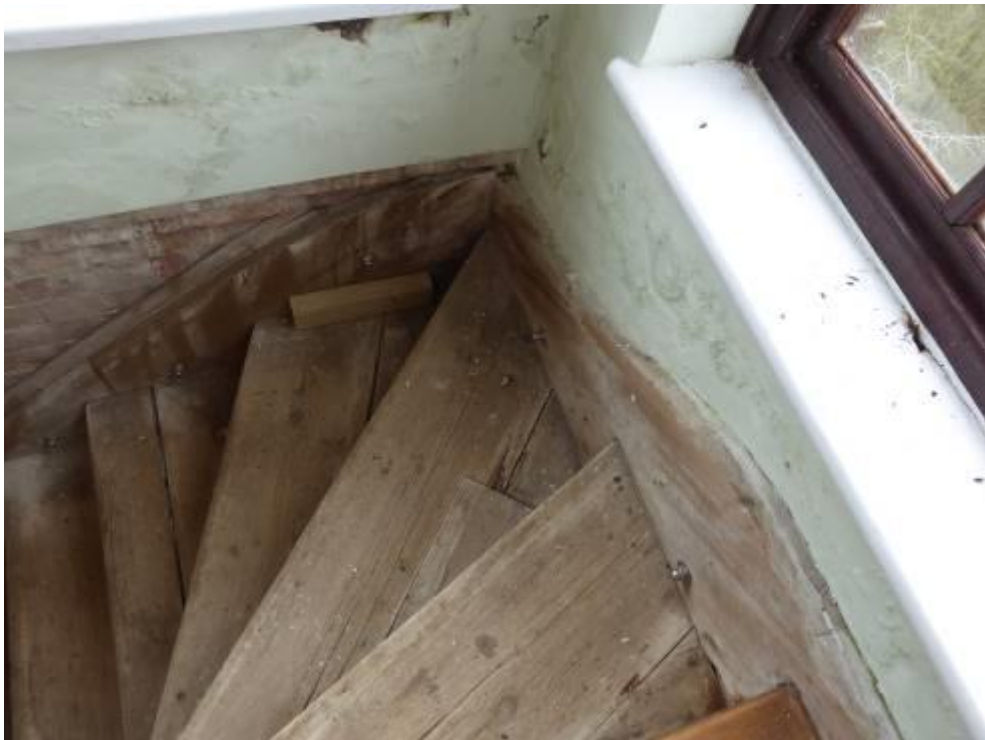
Figure 18 Detail of same with corresponding decay in stair joinery

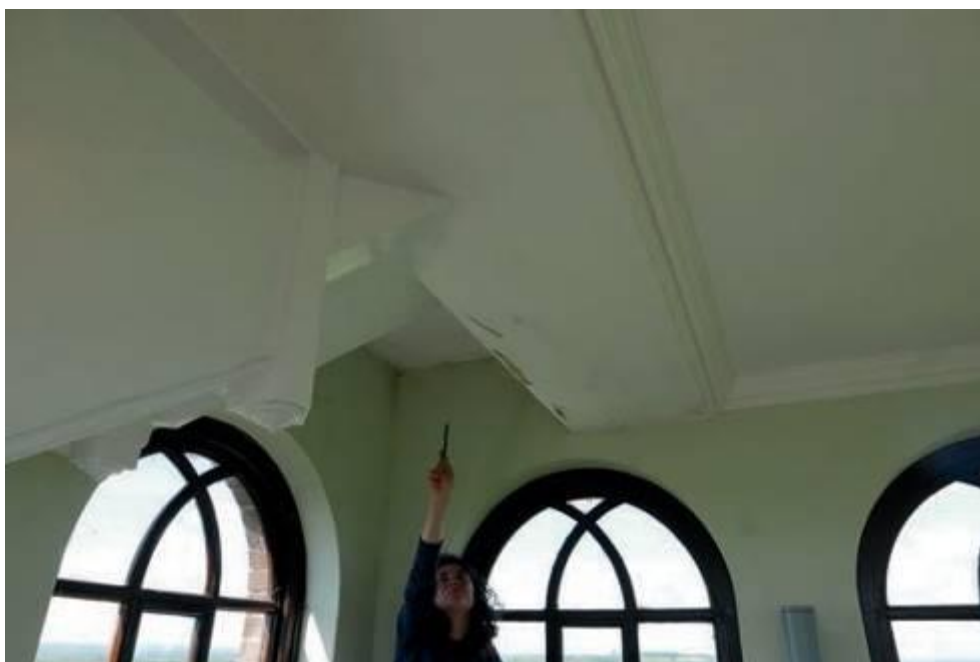
Figure 19 Mould growth and disruption of decorative finishes to west end of enclosed trimmer beam to ceiling of Belvedere room
